# OPTIMA ETF-660 and ETF-770 Faucets

### Parts List—ETF-660 and ETF-770 Faucets

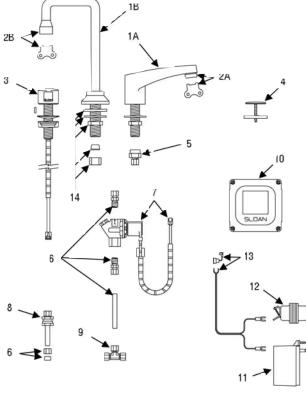
## Old-Style Faucets

ETF-66 and ETF-77 faucets manufactured before 1996 used an EL-350-A Microphone-Style Sensor with telephone jack connector (0305527) and an ETF-214-A Control Module (0305533)
