Model 600XL

Pressure Reducing Valve with Integral By-pass

(1/2", 3/4", 1", 1 1/4", 1 1/2" & 2")

□ Installation □ Testing □ Maintenance Instructions

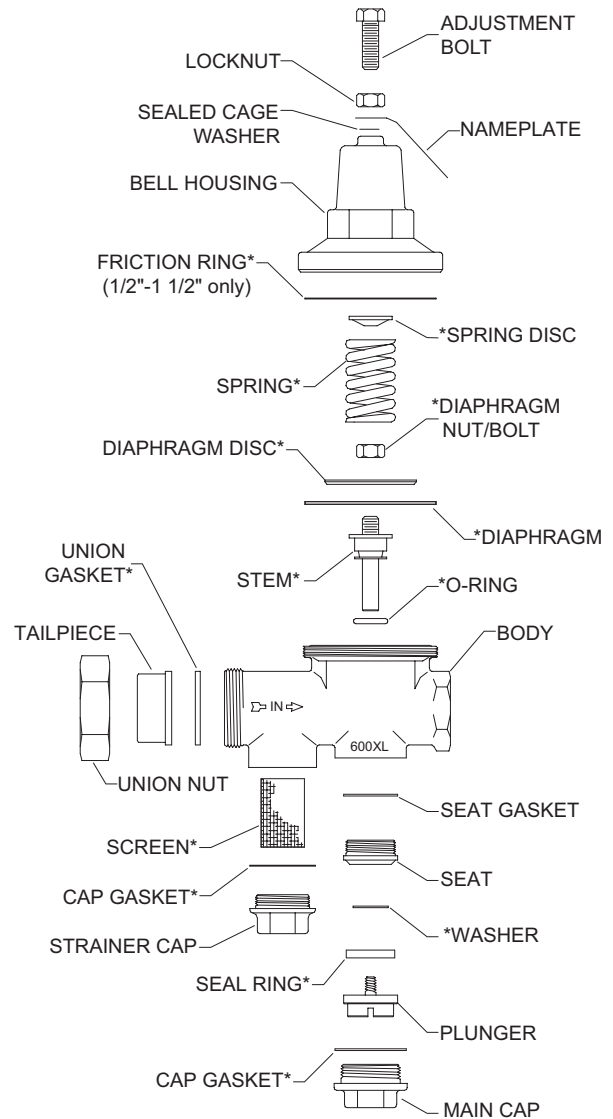
1. Open shut-off valve slowly and flush body and line of any debris.
2. Assemble new stem unit using new stem, o-ring, diaphragm, diaphragm disc and diaphragm bolt/nut. Tighten bolt/nut securely (CAUTION: Be sure the rounded edge of the diaphragm disc is next to the diaphragm).

3. Lubricate o-ring with grease supplied in repair kit and install stem unit in body.
4. Center washer on stem. Screw plunger into stem unit. CAUTION: Do not over tighten plunger; it is possible to break the threaded end of the plunger.

5. Install new spring, spring disc and friction ring then replace bell housing by tightening clockwise. Turn adjustment bolt clockwise until adjustment bolt touches spring disc.

6. Install new screen, cap gaskets and replace caps by tightening clockwise.
7. Turn adjustment bolt into bell housing to old setting then enter dwelling and turn on several faucets.

1. Open faucet on dwelling to remove line pressure.
2. Note distance that adjustment bolt protrudes from bell housing. Loosen locknut on adjustment bolt, then turn adjustment bolt out of bell housing until free of spring tension.
3. Loosen main cap and remove counterclockwise.
4. Loosen plunger and remove counterclockwise. Remove old seal ring then insert new seal ring.
5. Loosen strainer cap counterclockwise and remove screen.
6. Unscrew bell housing counterclockwise and remove spring, spring disc and friction ring.
7. Remove stem assembly from regulator. Inspect area in body where stem o-ring guides for pitting or scratches. Smooth bore with emery cloth if needed. This area must be smooth for the valve to function correctly.
