Crown® Flushometer

Crown® II (Obsolete)

Manual Flushometers

TROUBLESHOOTING GUIDE

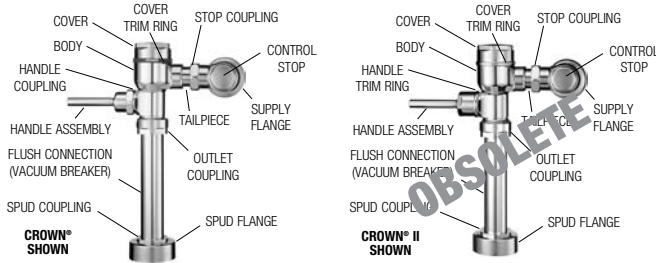
Piston Identification Chart	Water Closet		Urinal			
	CR-1004-A	CR-1011-A	CR-1005-A	CR-1006-A	CR-1015-A	CR-1014-A
Piston Color	3332003	3332013	3332004	3332004	3332017	3332016
Cap Color	1.6 gpf (6.0 Lpf)	1.28 gpf (4.8 Lpf)	1.0 gpf (3.8 Lpf)	0.5 gpf (1.9 Lpf)	0.25 gpf (1.0 Lpf)	0.125 gpf (0.5 Lpf)
Stem Grooves						
Barrel (Large Ribs or Small Ribs)	Large Ribs	Large Ribs	Small Ribs	Small Ribs	—	—
Cap Color	Green	Deep Purple	Yellow	Red	Burgundy	Pink
Piston Color	Green	Green	Clear	Clear	Burgundy	Burgundy
Barrel	Large Ribs	Large Ribs	Small Ribs	Small Ribs	—	—
Seat Color	Green	Green	Black	Black	Burgundy	Burgundy
Grooves	2	0	1	3	1	3
