Crown® Flushometer

Crown® II (Obsolete)

Manual Flushometers

PARTS LIST

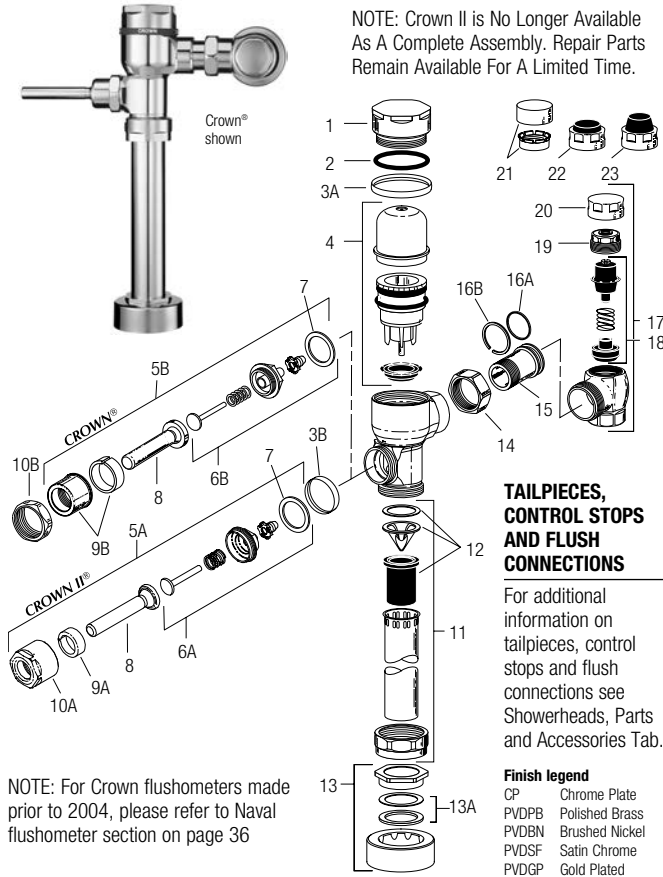
Item No.	Code No.	Part No.	Description
1.	0332006	CR-116	CP Cover
2.	0332030	CR-133	Cover O-ring
3.	0332045	CR-132-A	CP Handle and Cover Trim Ring Kit (Includes items 3A & 3B) (CROWN® II ONLY)
	0332046	CR-132-A	PVDPB Handle and Cover Trim Ring Kit (Includes items 3A & 3B) (CROWN® II ONLY)
	0332048	CR-132-A	PVDBN Handle and Cover Trim Ring Kit (Includes items 3A & 3B) (CROWN® II ONLY)
	0332049	CR-132-A	PVDSF Handle and Cover Trim Ring Kit (Includes items 3A & 3B) (CROWN® II ONLY)
3A.	0332035	CR-134	Cover Trim Ring (CROWN® ONLY)
	0332009	CR-120	PVDPB Cover Trim Ring (CROWN® II ONLY)
	0332032	CR-120	PVDGP Cover Trim Ring (CROWN® II ONLY)
	0332033	CR-120	PVDBN Cover Trim Ring (CROWN® II ONLY)
	0332034	CR-120	PVDSF Cover Trim Ring (CROWN® II ONLY)
3B.	0332005	CR-113	PVDPB Handle Trim Ring (CROWN® II ONLY)
	0332028	CR-113	PVDBN Handle Trim Ring (CROWN® II ONLY)
	0332029	CR-113	PVDSF Handle Trim Ring (CROWN® II ONLY)

4.	3332003	CR-1004-A	Piston Kit – 1.6 gpf (6.0 Lpf) Water Closet
	3332013	CR-1011-A	Piston Kit – 1.28 gpf (4.8 Lpf) Water Closet
	3332004	CR-1005-A	Piston Kit – 1.0 gpf (3.8 Lpf) Urinal
	3332005	CR-1006-A	Piston Kit – 0.5 gpf (1.9 Lpf) Urinal
	3332017	CR-1015-A	Piston Kit – 0.25 gpf (1.0 Lpf) Urinal
	3332016	CR-1014-A	Piston Kit – 0.125 gpf (0.5 Lpf) Urinal

ALL PISTON KITS INCLUDE MAIN SEAT (see item 4 table to right) AND CR-124-A INSIDE COVER ASSEMBLY AS SHOWN IN ITEM 4. PISTON KIT COMPONENTS TABLE TO THE RIGHT.

Item No.	Code No.	Part No.	Description
5A.	0302353	B-30-A	ADA-Compliant Handle Assembly CP
5B.	0302390	B-73-A	ADA-Compliant Handle Assembly CP
6A.	3332006	CR-1007	Handle Repair Kit
6B.	3302306	B-51-A	Handle Repair Kit

7.	5301139	A-31	Handle Gasket – 48/pkg
8.	0302389	B-74-A	Handle Grip Sub-Assembly ADA
9A.	0302309	B-56	Sleeve
9B.	0302109	B-7-A	CP Socket Assembly
10A.	0302354	B-53	Handle Socket
10B.	0301082	A-6	CP Handle Coupling

11.	3393004	V-600-AA	3/4" x 9" (19 x 229 mm) Vacuum Breaker - 6/pkg
	3393006	V-600-AA	1-1/4" x 9" (32 x 229 mm) Vacuum Breaker - 6/pkg
	3393007	V-600-AA	1-1/2" x 9" (38 x 229 mm) Vacuum Breaker - 6/pkg

12.	3323182	V-651-A	High Back Pressure Vacuum Breaker Repair Kit
13.	3332000	CR-1008-A	3/4" (19 mm) Spud Coupling Assembly
	3332001	CR-1009-A	1-1/4" (32 mm) Spud Coupling Assembly
	3332002	CR-1010-A	1-1/2" (38 mm) Spud Coupling Assembly
13A.	SEE SLIP JOINT GASKETS AND RINGS TABLE ON BOTTOM, PAGE 25

14.	0308676	H-550	Stop Coupling
15.	0308801	H-551-A	Adjustable Tailpiece (2-1/16" (52 mm) long)
16A.	5308696	H-553	O-ring – 24/pkg
16B.	5308381	H-552	Locking Ring – 12/pkg

17.	0388000	H-700-A	1" Screwdriver Bak-Chek® Stop CP
	0388001	H-700-A	3/4" Screwdriver Bak-Chek® Stop CP
18.	3308853	H-541-ASD	Control Stop Repair Kit†
	3308856	H-543-ASD	Control Stop Repair Kit† for 3/4" Stops H-600, H-640

19.	0308612	H-622	CP Bonnet †
	0308843	H-577	CP Bonnet † – OBSELETE
20.	3308840	H-573-A	Locking Vandal Resistant Control Stop Cap includes H-573 Stop Cap CP and H-648 Friction Ring †
	0308848	H-582	Locking Vandal Resistant Control Stop Cap CP †

21.	3308651	H-651	Vandal Resistant Control Stop Cap Assembly †
22.	3308866	H-574	Control Stop Cap w/Bumper (-YO Variation) †
23.	3308867	H-576	Control Stop Cap w/Extended Bumper (-YG Variation)†
—	0305190	EL-190-A	Handle Adapter (manual only) for Optima® version (not shown) to convert to manual

ITEM 4. PISTON KIT COMPONENTS

Item	Code No.	Part No.	Description
A.	0332000	CR-124-A	Inside Cover Sub-Assembly
B.	***	***	Piston Cover
C.	5332095	CR-68-A	Molded Cup – 12/pkg
D.	5328019	SH-406	Spring – 12/pkg
E.	***	***	Relief Valve
F.	0307116	G-95	Relief Valve Seat
G.	***	***	Piston Body
H.	0332013	CR-125-A	Main Seat – 6/pkg (1.0 gpf and 0.5 gpf)
	0332120	CR-167-A	Main Seat – 6/pkg (Water Closets ONLY)
	0332126	CR-170-A	Main Seat – 6/pkg (0.25 gpf and 0.125 gpf)
I.	0307210	G-85	Filter O-ring
J.	0305135	EL-110	O-ring (for use with CR-125-A main seat ONLY)*
	0308958	H-589	O-ring*

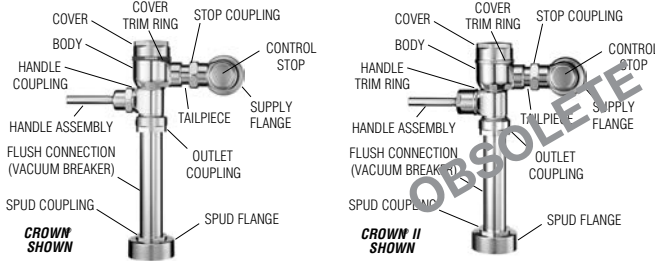
Piston Identification Chart	Water Closet		Urinal			
	CR-1004-A	CR-1011-A	CR-1005-A	CR-1006-A	CR-1015-A	CR-1014-A
	3332003	3332013	3332004	3332004	3332017	3332016
	1.6 gpf (6.0 Lpf)	1.28 gpf (4.8 Lpf)	1.0 gpf (3.8 Lpf)	0.5 gpf (1.9 Lpf)	0.25 gpf (1.0 Lpf)	0.125 gpf (0.5 Lpf)
Cap Color	Green	Deep Purple	Yellow	Red	Burgundy	Pink
Piston Color	Green	Green	Clear	Clear	Burgundy	Burgundy
Barrel	Large Ribs	Large Ribs	Small Ribs	Small Ribs	-	-
Seat Color	Green	Green	Black	Black	Burgundy	Burgundy
Grooves	2	0	1	3	1	3
